Subject: Five-Year Review Report

Superfund Five-Year Review Report

Petroleum Products Corporation Town of Pembroke Park, Broward County, Florida

Prepared for U.S. Environmental Protection Agency, Region IV August 2000

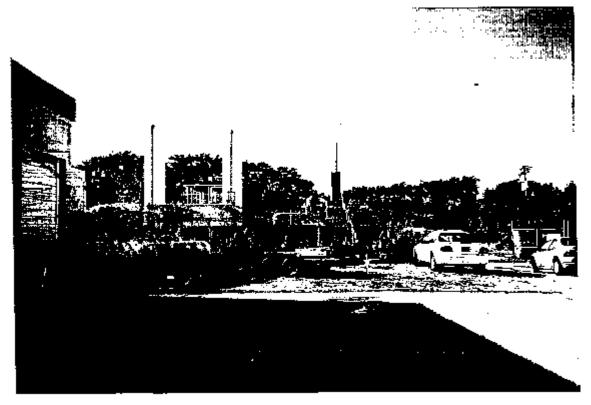
Photograph #2 March 21, 2000 Location: Petroleum Products Superfund Site, Broward County, Pembroke Park, Florida Description: View of treatment compound including two air stripping towers and privacy fence looking south.

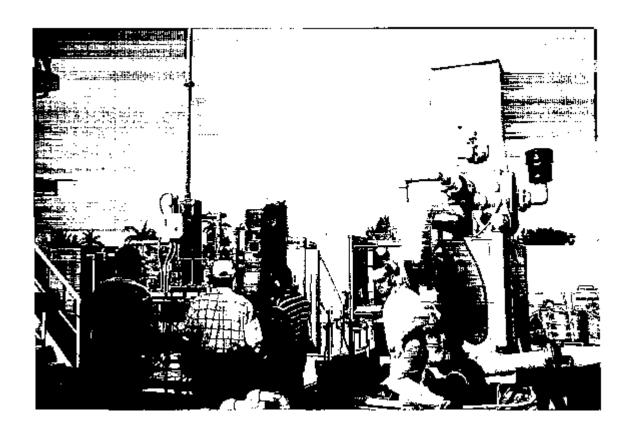
Photograph #4 March 21, 2000 Location: Petroleum Products Superfund Site, Broward County, Pembroke Park, Florida

Description: View looking toward west at oil/water separator and catalytic oxidizer.

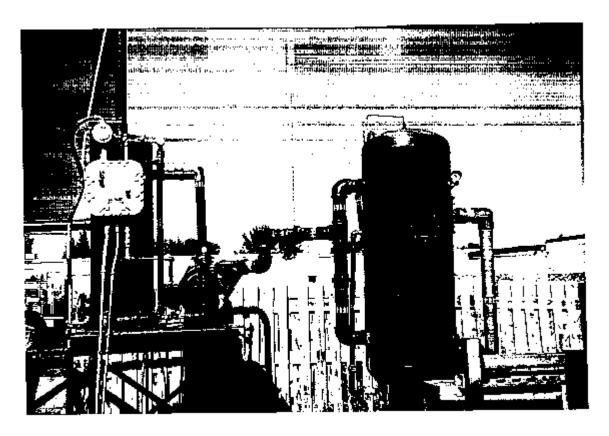
Photograph #5 March 21, 2000 Location: Petroleum Products Superfund Site, Broward County, Pembroke Park, Florida.

Description: Oil water separator

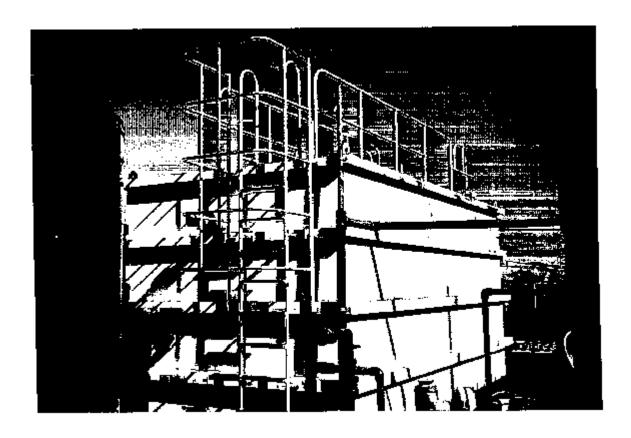
Photograph #6 March 21, 2000 Location: Petroleum Products Superfund Site, Broward County, Pembroke Park, Florida

In September Battelle recommended a design change to the treatment system by adding a 18,000 gallon settling tank upstream of the GAC units. This was approved and installed utilizing an existing tank from FDEP's surplus equipment. EPA sent a letter on October 6 noting spill prevention control concerns with the increase in storage capacity.

Description: 18,000 gallon settling tank

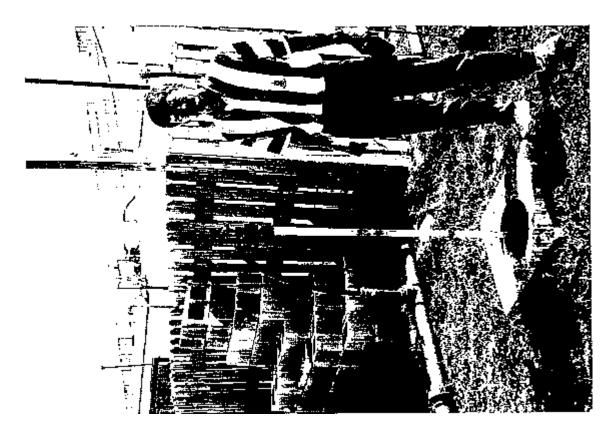
Photograph #7 March 21, 2000 Location: Petroleum Products Superfund Site, Broward County, Pembroke Park, Florida.

Representative photographs of monitoring and extraction wells observed during the site inspection are provided at the end of this report. Wells which were located outside of the Phase 1 area were either flush-mounted with the asphalt pavement, or recessed within an access pit with a hinged metal cover. The metal cover was unlocked. Extraction wells located within the security fence area were observed to have riser pipes connected to the extraction ports, which were installed within a small open access pit. The top of the riser pipe had a valve which controls the flow rate to the piping which feeds to the manifold area (see Photograph #7). The wells which were observed appeared to be in good condition.

Description: Bioslurping Well #17 looking northeast

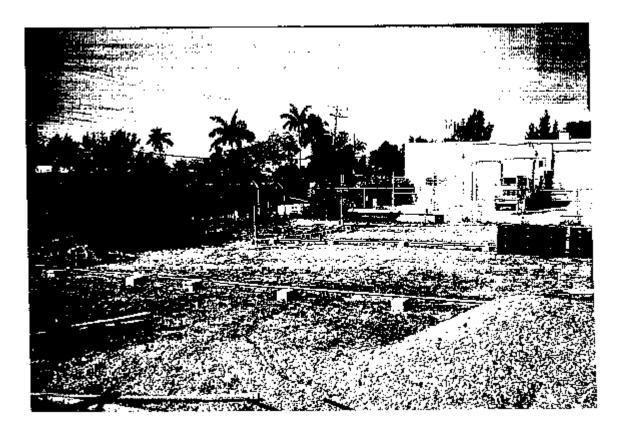
Photograph #8

Description: Bioslurping well network looking west

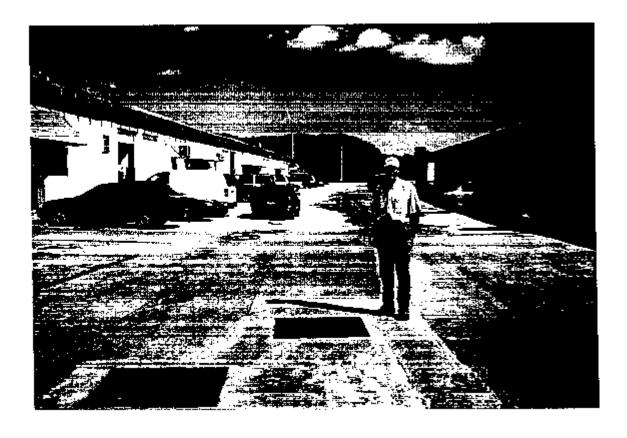
Photograph #10 March 21, 2000 Location: Petroleum Products Superfund Site, Broward County, Pembroke Park, Florida Description: Infiltration gallery looking toward gallery.

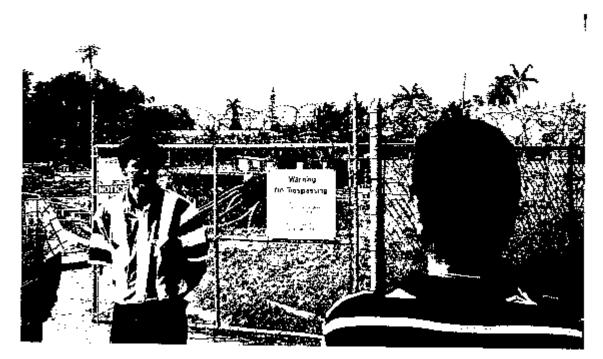
Photograph #11 March 21, 2000 Location: Petroleum Products Superfund Site, Broward County, Pembroke Park, Florida.

Warning signs were noted at the Site during BBL's initial site inspection.

Description: Warning sign posted at entrance gate
